Field Performance of Long-Strand Wood Erosion Control Mulch and Agricultural Straw Under Natural Rainfall Events

James H. Dooley, David N. Lanning, John E. Burks
Forest Concepts, LLC
March 20, 2005

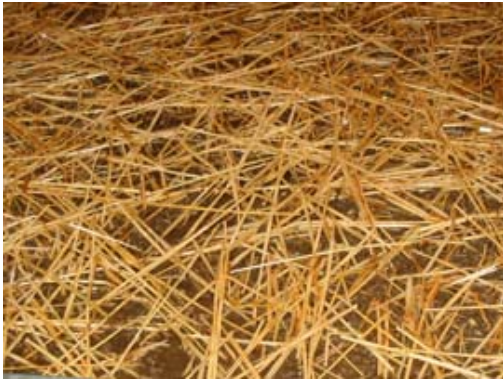
Figure 1. Agricultural wheat straw at 70 percent cover

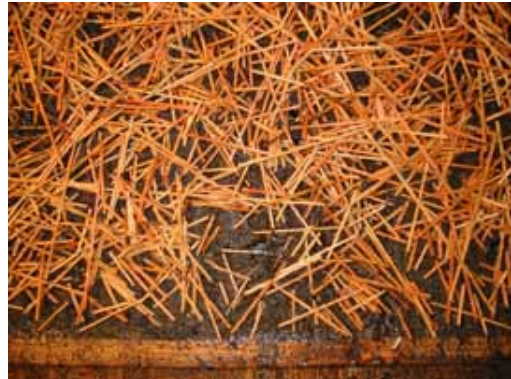
Figure 2. A “high storage” blend of WoodStraw™ material at 70 percent cover.

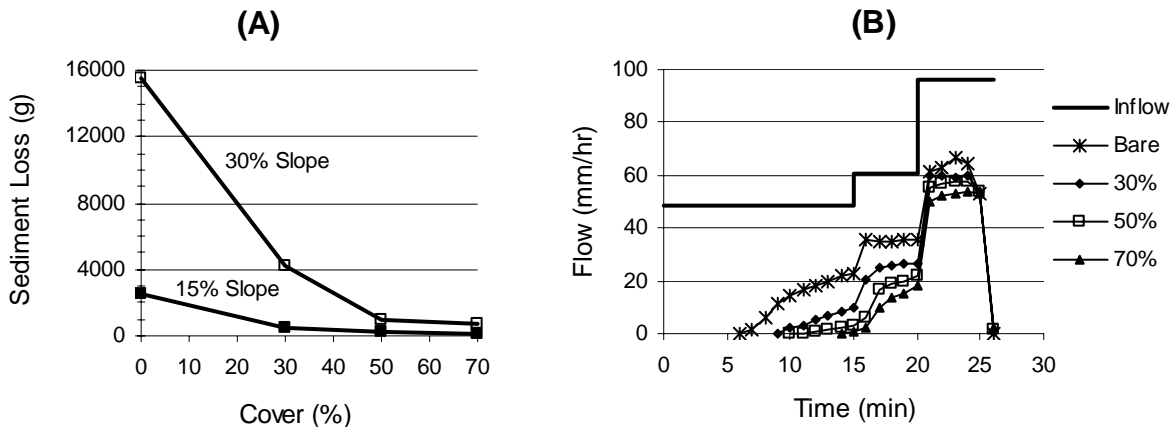
Figure 3: Sediment loss (A) and runoff hydrograph (B) for varying cover amounts of wood strands.

The USFS data shows that very effective erosion control can be obtained at 50% groundcover. This is in contrast to similar performance of wheat and rice straw at 90% cover or higher (Burroughs and King

1989). Also, the figure shows a dramatic reduction in runoff from the plots covered with wood strands. Reduced runoff due to increased infiltration captures more rainfall to support plant growth and reduces the risk of downslope flooding.

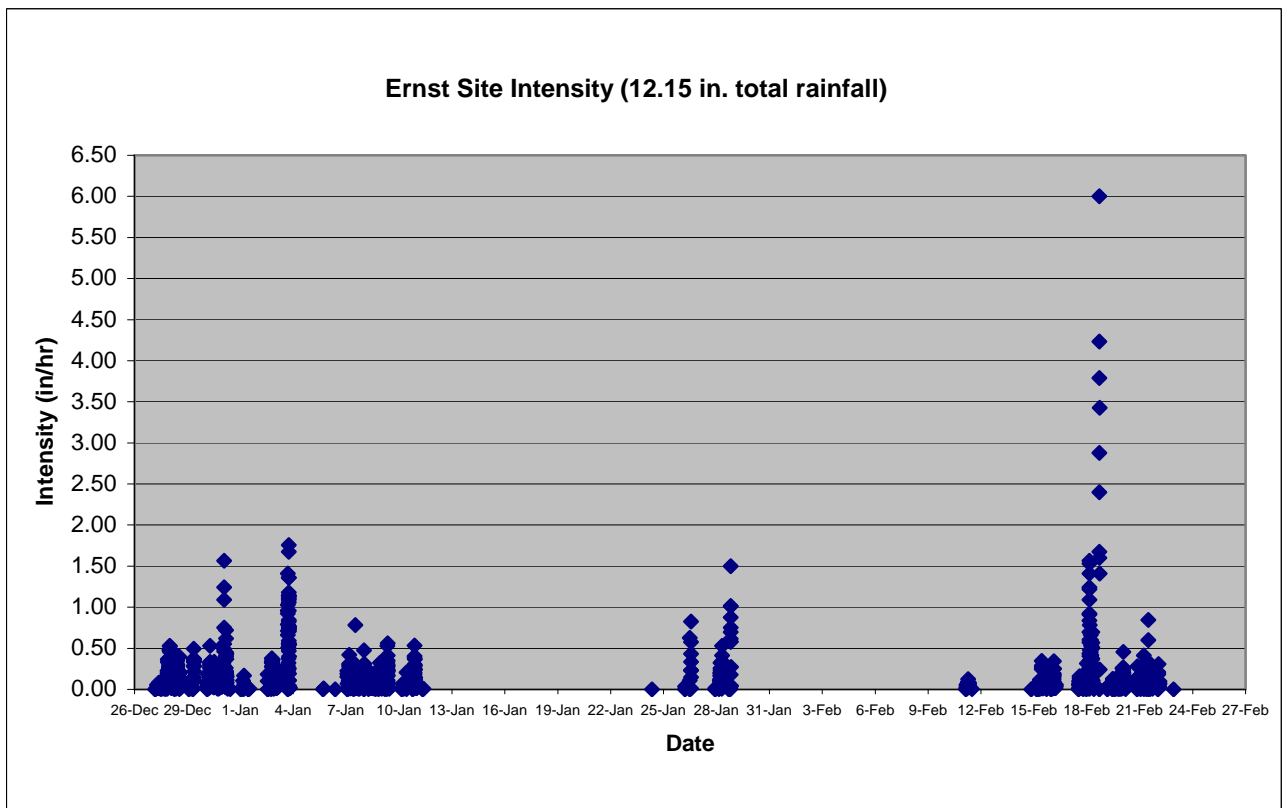
Figure 6. Rainfall intensity at Ernst site from December 26, 2004 through February 28, 2005.

The intensity graph in Figure 6 shows that the site was subject to five short duration events where the intensity exceeded one inch per hour. There were approximately sixteen events where the rainfall intensity exceeded the landowner's one-half inch per hour estimate of soil infiltration rate.

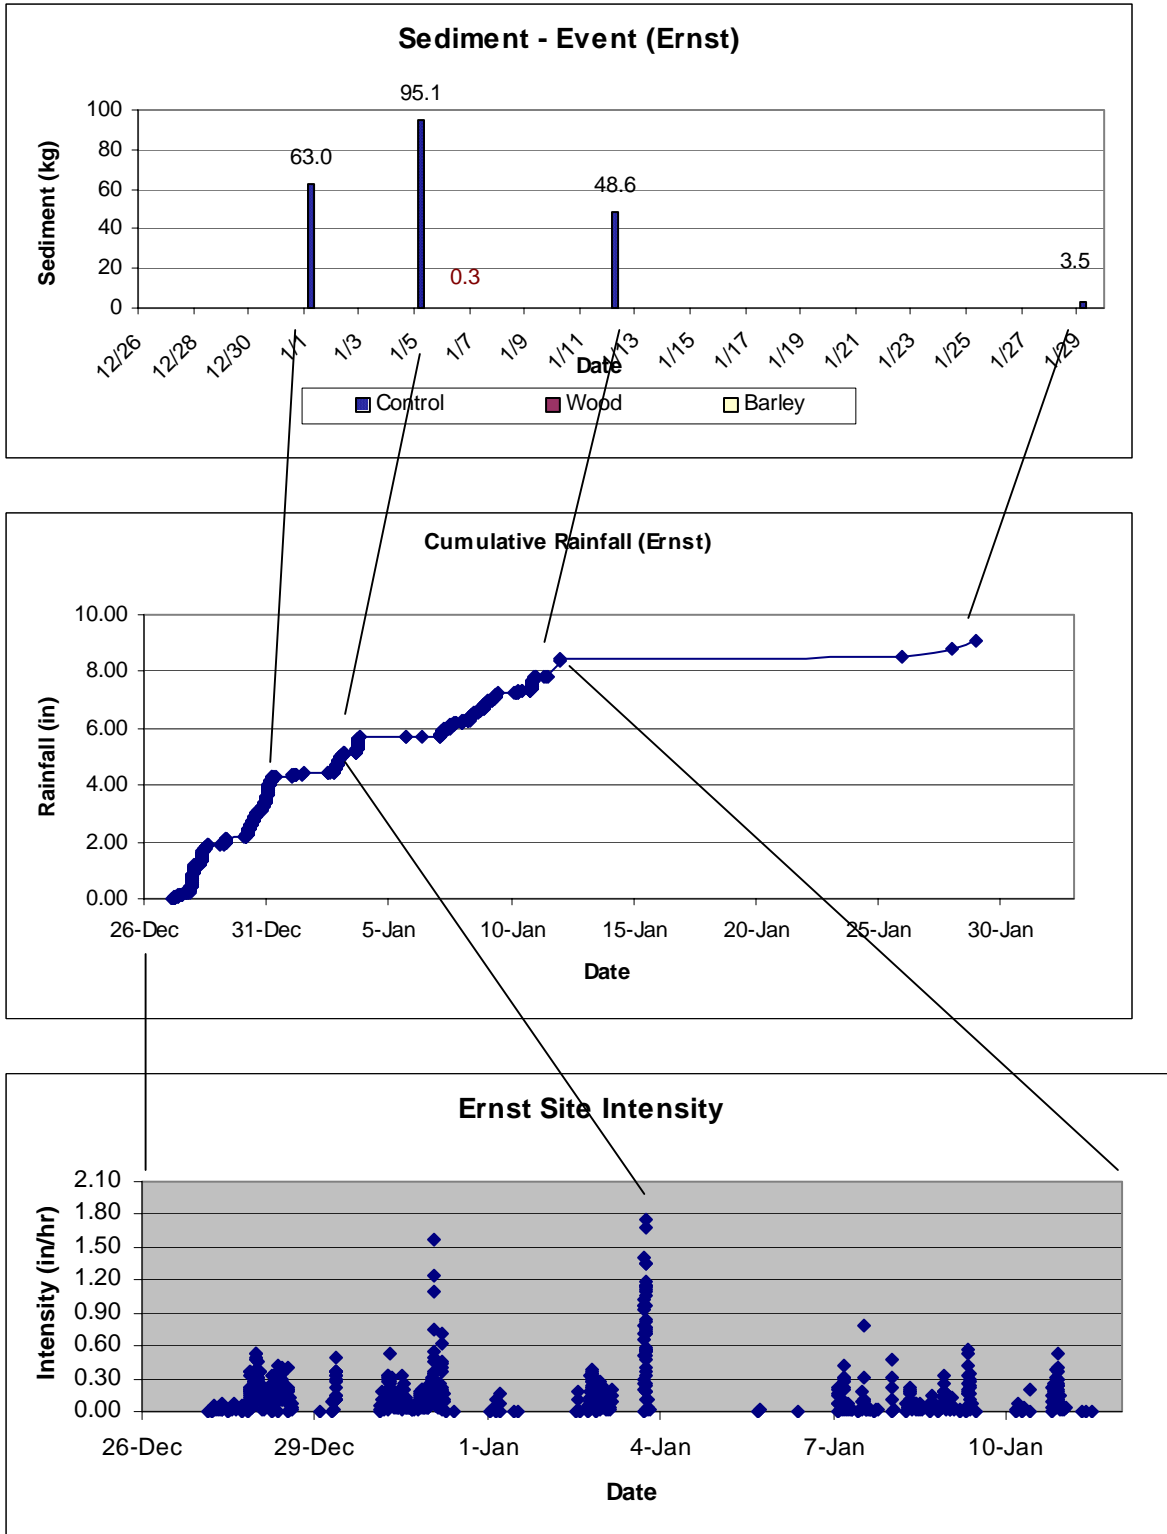
Figure 7. Linked graphs from Ernst Site for the period December 26, 2004 through January 30, 2005.

If we consider the first series of storms that occurred after installing the plots, we can show the relationship between rain intensity and sediment delivery from the site. The landowner collected sediment at the first day after each storm when he could get to the site. The first rain event on December 28-29 did

not produce runoff from any of the plots. However, the December 30-31 event produced runoff from the bare soil plot. A total of 63kg (139 lb) (dry weight) of sediment was removed from the bare soil plot and nothing was recovered from the straw or wood-strand plots.

A larger rainfall event on January 3-4 resulted in 95kg (209 lb) of additional sediment from the bare soil plot, 0.3 kg (10 ounces) of sediment from the wood-strand plot and still no sediment from the straw plot. As can be seen from the figure, additional runoff and sediment occurred on the bare soil plot at each major event, but no additional sediment was delivered from either the straw or wood-strand plots.

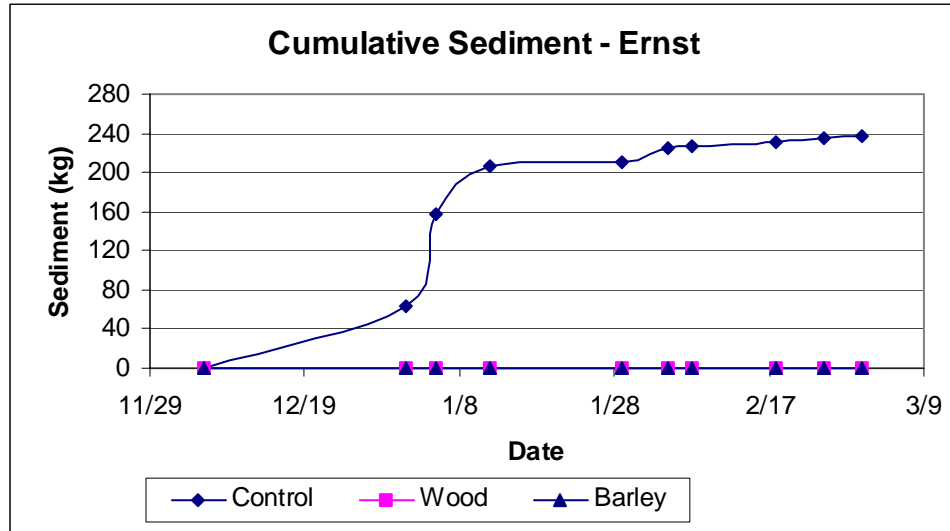
Figure 8. Cumulative sediment for treatments at Ernst site. As of February 28, the cumulative amount for bare soil plot was 238kg, the wood-strand plot was 0.3kg and 0.0kg for barley straw plot.

The Ernst site near Paso Robles, California received nearly 12 inches of rainfall during the three-month study period. Rainfall included approximately sixteen events where the intensity exceeded infiltration, and six events where the intensity exceeded 1.5 inches per hour. More than 230 kg of sediment eroded from the bare soil control plot, while only 0.3 kg eroded from the wood-strand plot and none eroded from the straw mulch plot. In agronomic terms, the bare plot eroded at a rate of 7.3 tons per acre.

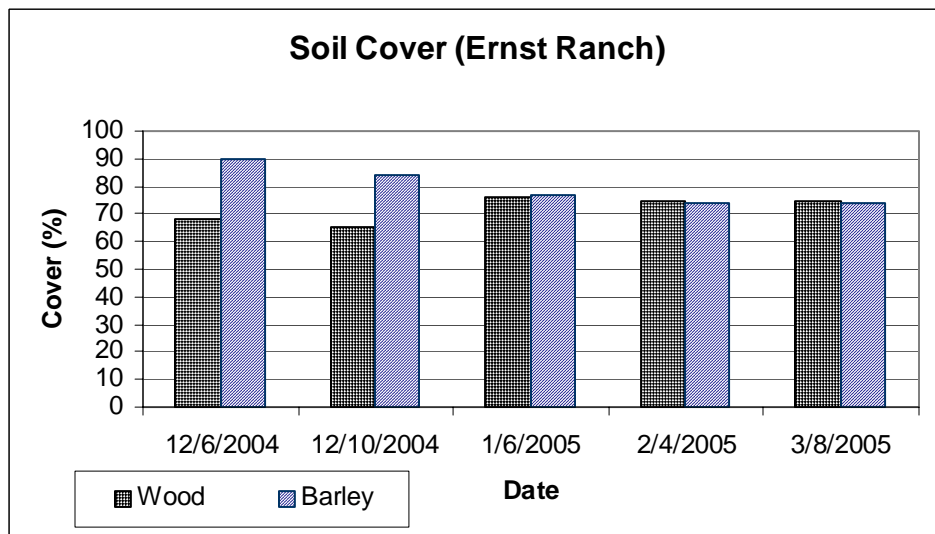
Figure 9. Measured soil cover for wood-strand mulch and barley straw mulch.

As noted earlier, the target application rate for barley straw was 90 percent and for wood-strands was 70 percent. Measurements of mulch coverage were taken using a point-intercept grid on a clear acrylic sheet. The square grid had 64 points spaced 40 mm apart. The grid was placed at twelve semi-random locations

on the upper, middle, and lower sections of the plot. Points directly above functional mulch pieces were considered “hits.” Total hits as a percentage of total points were used to determine the percent cover.

Over the three months from December 6 through March 8, the wood-strand cover continued to be approximately 70 percent. Variation from observation-to-observation is visible in Figure 9; however, the cover differences are not significant. The cover for barley straw has declined from an initial 90 percent to a March 8 cover of approximately 70 percent. By observation the reduction is due to loss of leaf area as the leafy component decays. The current cover is primarily due to stalk material.

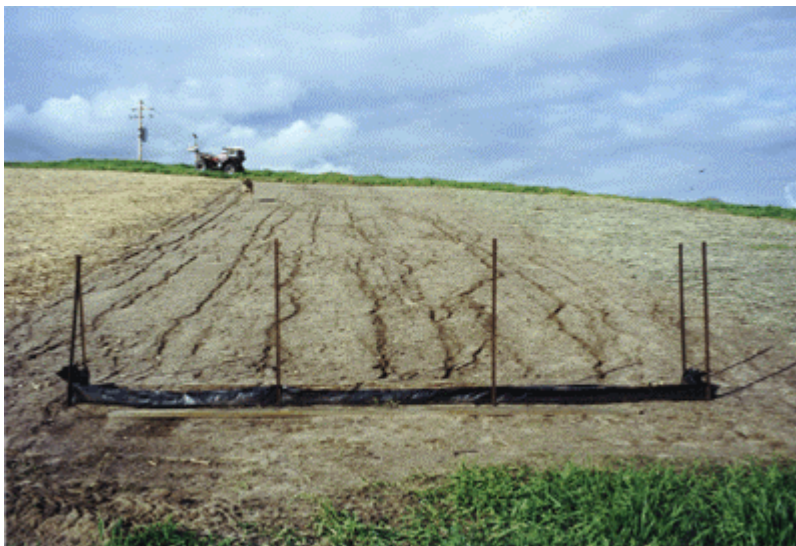
Figure 10: Ernst site on January 3, 2005 with wood-strand plot on the left, bare soil in the center, and barley straw plot on the right. As of this date, neither of the treated plots showed any signs of rill erosion.

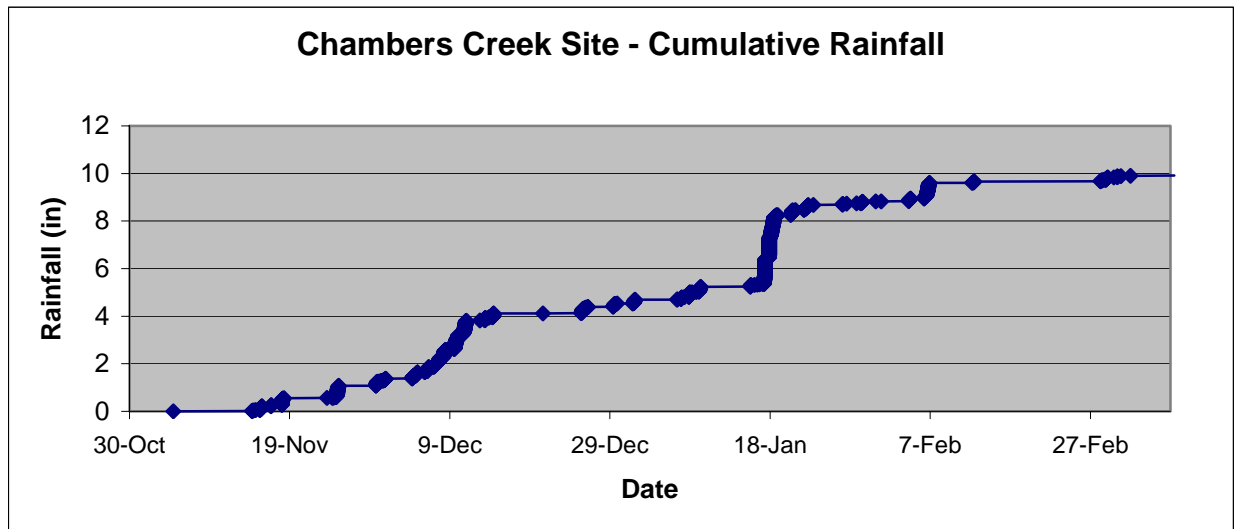
Figure 11. Cumulative rainfall for Chambers Creek site.

The Chambers Creek experiment was installed on November 3-4, 2004 and continued through the end of February 2005. The experiment will continue informally until the site is graded later in 2005. Figure 11 shows the cumulative rainfall for the study period. In addition to cumulative rainfall, we were able to calculate instantaneous intensity for each tip of the rain gauge (0.01 in) as shown in Figure 12.

The Chambers Creek site received nearly ten inches of rainfall during the three-month study period. This is approximately half of what is expected in a normal winter. The site did not receive any snow. Three events included rainfall intensity above one-half inch per hour. Only one event exceeded one inch per hour. Surprisingly, the event on January 18 did not result in an increase in sediment. We suspect that the event, though intense, did not exceed the infiltration capacity of the glacial sand soil. Inspection of the plots indicated that water did pond on the surface and move some sediment short distances (less than 0.5 m) within both the wood-strand and wheat straw plots.

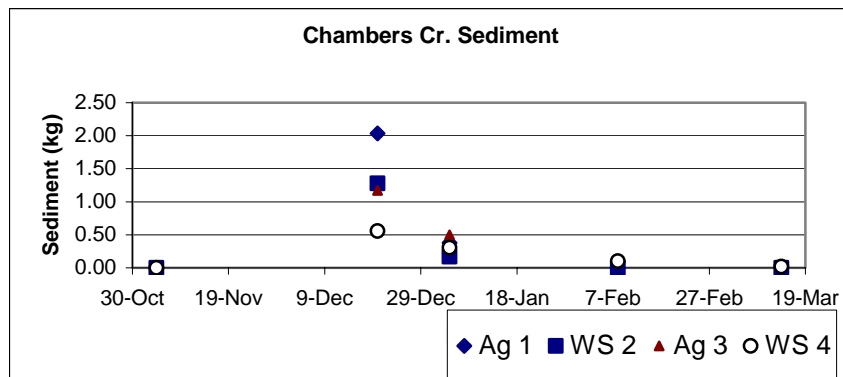
Figure 13. Measured sand sediment from Chambers Creek plots versus date. Additional large stones from dry ravel is not included.

The amount of sediment captured at the Chambers Creek site was a fraction of the amount that we expected. Although inspection of Figures 13 and 14 suggests that the wood-strand plots had consistently less sediment than the wheat straw plots, the differences are probably not significant. Adjacent to the shallow slope plots, we installed a silt collector on an open area as a bare soil control. To date, there has been no sediment delivered from the bare soil plot.

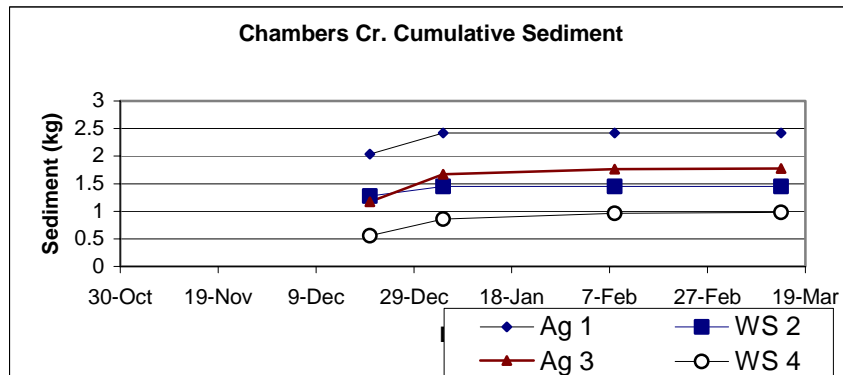
Figure 14. Cumulative sand sediment from Chambers Creek plots versus date.

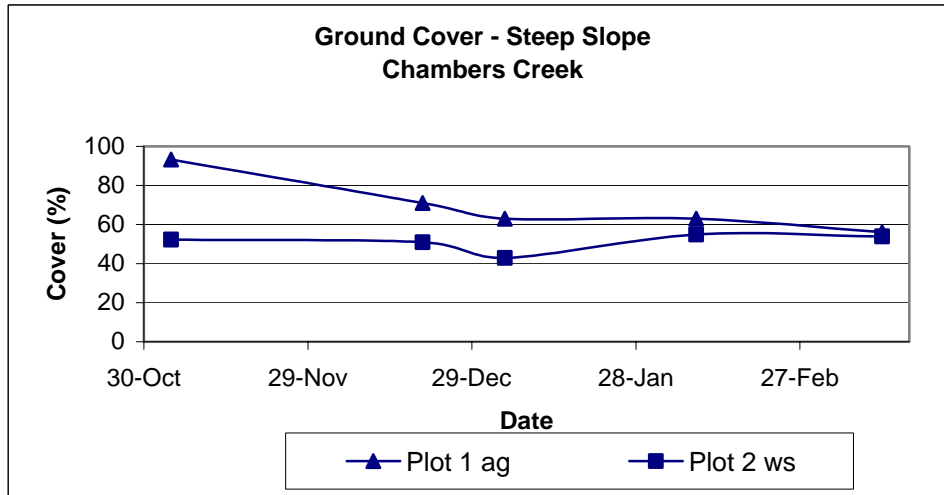
Figure 15. Measured ground cover over time for the Chambers Creek steep slope plots.

The initial application rates for wheat straw and wood strands were 90% and 50% respectively. The wood-strand material has maintained a constant soil cover throughout the study period. Variance from observation to observation are not significant. As was expected, the wheat straw lost leafy material over the first 6-8 weeks, leaving the more persistent stalks at a cover of 55 – 60 percent.

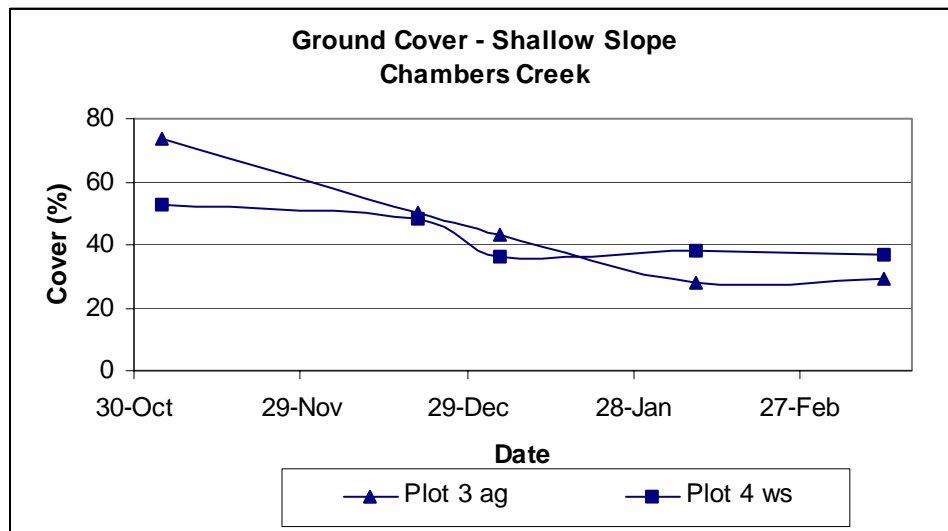
Figure 16. Measured ground cover over time for the Chambers Creek shallow slope plots.

Although the target initial cover for wheat straw on the shallow slope plot (ag 1) was 90 percent, the actual measured initial cover was 74%. Initial cover for the wood-strands was 53%. The coverage of both materials has declined over time to where the current coverage is 29% and 37% for the straw and wood-strands respectively. We do not have a ready-explanation for the loss of wood strands, and the more extreme loss of wheat straw cover. The site is in an open area, and there is ample sign of birds including eagles, other raptors, seagulls, and smaller birds using the site. The most likely explanation is that birds and small mammals are collecting the straw materials and removing them from the plots.

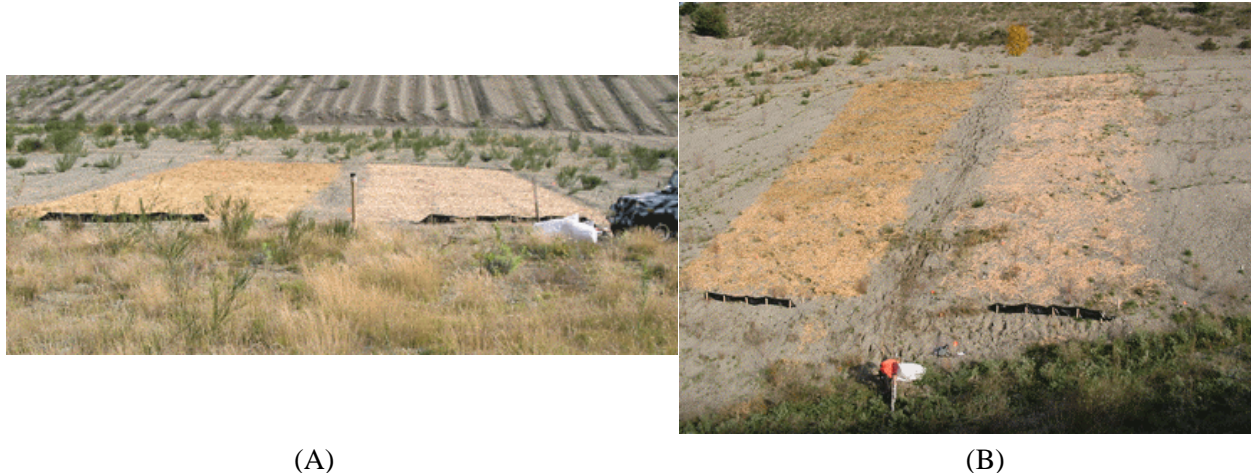
Figure 17. Overview of Chambers Creek plots. Shallow slope (A) and steep slope (B).
